COCA-COLA NORTH AMERICA EQUIPMENT BULLETIN SERVICE

NUMBER: SERV-369

SUBJECT: Mark 4 Bargun Manifold and Button Issues

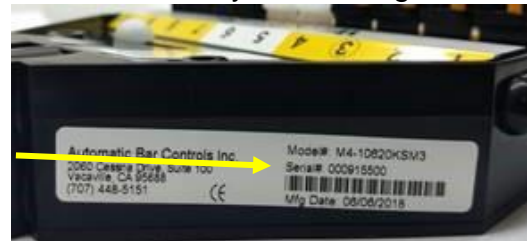
Please take an up-close photo of the serial number on the control tube of any defective manifold replaced regardless of the serial number. Also, take photos of any unopened bargun boxes within the serial number range 000903970–000958424. Email [Nicholas Jeffries \(link\)](#) with your photos. Also email him to offer up any barguns that required replacement, due to sticking buttons. A short video showing the sticking buttons will help. If Nicholas still needs defective samples to investigate, he will ask you to package and ship them to the below address.
