# COCA-COLA NORTH AMERICA EQUIPMENT BULLETIN SERVICE

**NUMBER:** SERV-376

**SUBJECT:** Stalled G55 Pump Troubleshooting Process

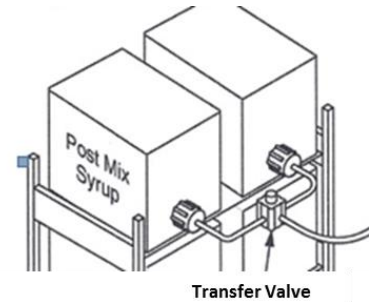
1. If an Automatic Switchover Valve (ASV, aka Transfer Valve) is installed, before taking any action, verify the ASV is not connected to an empty BIB.
  - a. If it is connected to an empty BIB, manually switch the valve to a BIB with syrup.  
ASV may need to be cleaned or replaced.
  - b. If pump and ASV are operational, action is complete.
  - c. If pump does not operate, proceed to next steps.

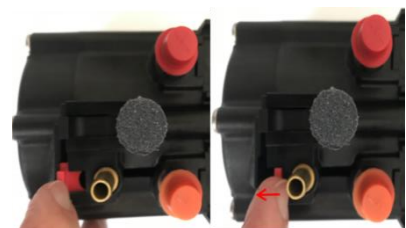
4. Remove CO<sub>2</sub> inlet fitting. CO<sub>2</sub> will release but should immediately stop. A short “puff” should be all that is heard.
  - a. If CO<sub>2</sub> continues to flow, re-insert inlet fitting immediately and turn off CO<sub>2</sub> tank.
  - b. With CO<sub>2</sub> tank Valve closed, remove CO<sub>2</sub> inlet fitting for inspection.
