# Technical Service Bulletin

| Product Category | Model(s) Affected | Date Issued |
|---|---|---|
| Sanitizers | <b>IntelliChlor Plus &amp; LT SCGs</b><br><b>IntelliCenter / IntelliChlor Plus40 Bundles</b><br>523741; 523747; 523730; 523735; 523738; 523744;<br>523750; 523733; 523744-EC; 523747-EC; 523735-EC;<br>523770; 523961; 523962; 523964; 523965; 523966;<br>523967; 523968; 523969; 523914; 523963 | October 27, 2025 |
| HMI Controller Assembly Firmware Update – from 1.003 to 1.004 | | A00709 |

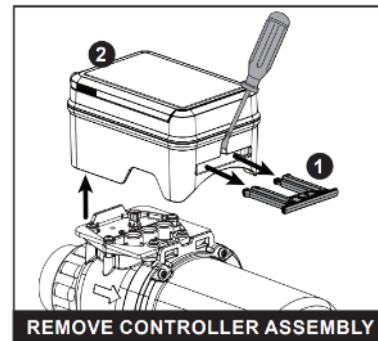
2. Using a flat blade screwdriver, gently pry the *Retaining Clip (1)* from the *Controller Assembly (2)* and place it aside.
3. Gently lift the *Controller Assembly (2)* from the cell and place it aside in a dry area.

**NOTICE** Shifting or shimmying the Controller Assembly side to side during removal may damage connection terminals. Only lift upwards.

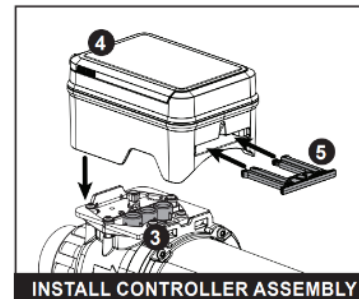
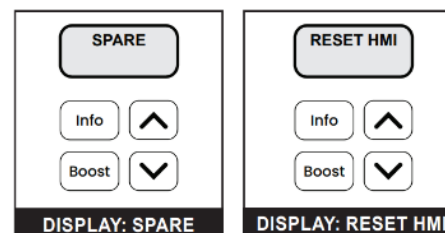
- **SPARE:** No further action is needed. The controller will automatically sync historical and run-time data with the cell.  
OR;
- **RESET HMI:** Controller must be manually RESET before it can pair to the cell. Continue to the *Pairing a Previously-Used Controller (Reset HMI)* section below.

1. Using the provided dielectric grease, thoroughly coat all three *Sensor-Controller Connections (3)*.
2. Place the *Controller Assembly (4)* onto the cell and gently push down to ensure connections are tight.
3. Reinstall the *Retaining Clip (5)* and ensure the *Controller Assembly (4)* can no longer be separated from the cell body.
4. Reestablish power to the filter pump, automation controls and SCG at the main breaker.
5. After repowering, the controller will display one of following messages:

**Allow up to 45 seconds for pairing to complete**
