# City of San Antonio Public Swimming Pool Energy Efficiency Retrofit Final Report

May 15, 2015

**Steve Easley & Associates, Pentair Aquatic Systems,  
AquaStar Pool Products, City of San Antonio**

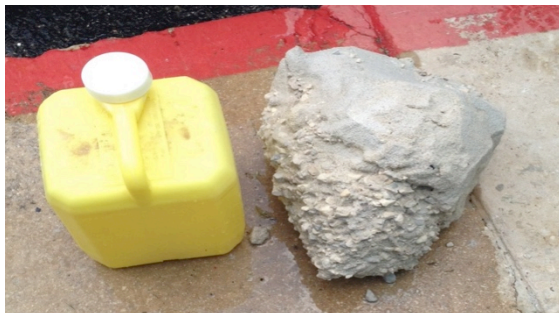
*Non-compliant filter media causing high TDH*

considerable energy savings potential did not have payback times under the threshold because of much higher equipment costs. For example, some existing motors were not compatible with VFD technology, and new motor costs combined with VFD and ancillary costs would have pushed ROI outside the payback time threshold. In another example, the detailed hydraulic audit helped identify filter media and backwash system piping / valve problems that were causing extreme back-pressure (high TDH) and poor water quality. Given the preexisting water quality challenges associated with this pool, the payback time threshold was discounted and retrofit energy efficiency savings were used to offset both the energy saving and hydraulic retrofit costs.

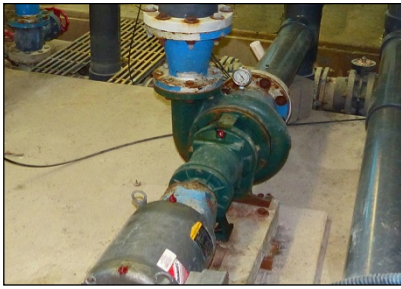
*Photo 1: Single pump system*

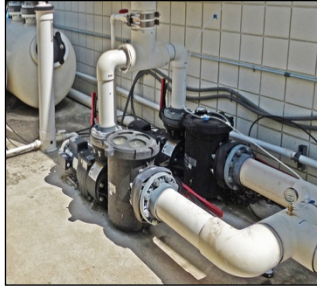
*Photo 2: Dual pump system*

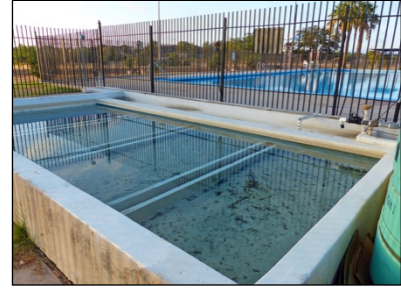
*Photo 3: Gravity filter system*

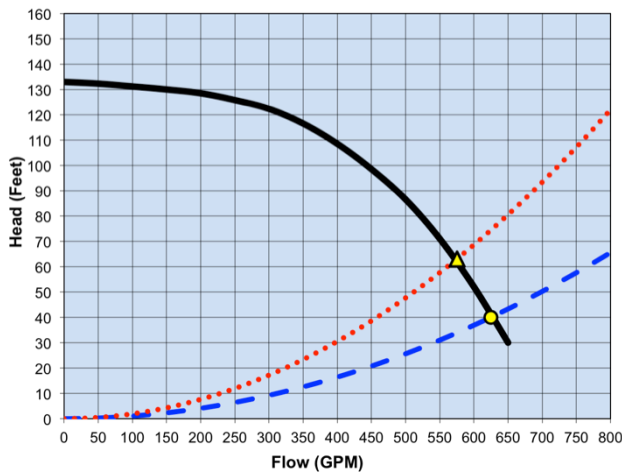
Chart 4: System curves for dirty filter (red) & clean filter (blue) with pump at full speed

ANSI swimming pool standards and building codes have long required pumps to be large enough to overcome the back pressure caused by dirty filters. This means single speed pumps will typically consume more electricity when the filter is clean compared to when it is dirty, because clean filters provide higher flow rates (chart 4). The increase energy consumption is due to the fact the pump is doing more work. For this reason, filter loading usually does not impact energy consumption associated with single speed pump systems. It would if single speed filtration were programmed for a fixed number of turnovers per day using a totalizing flow sensor and control system that turns off the pump once the program turnovers are achieved. Chart 4 is the pump and system curves as measured at Pool 1. The pump used 13.22 kW when the filter was clean and only 12.99 kW when a 10 psi filter pressure rise was simulated.

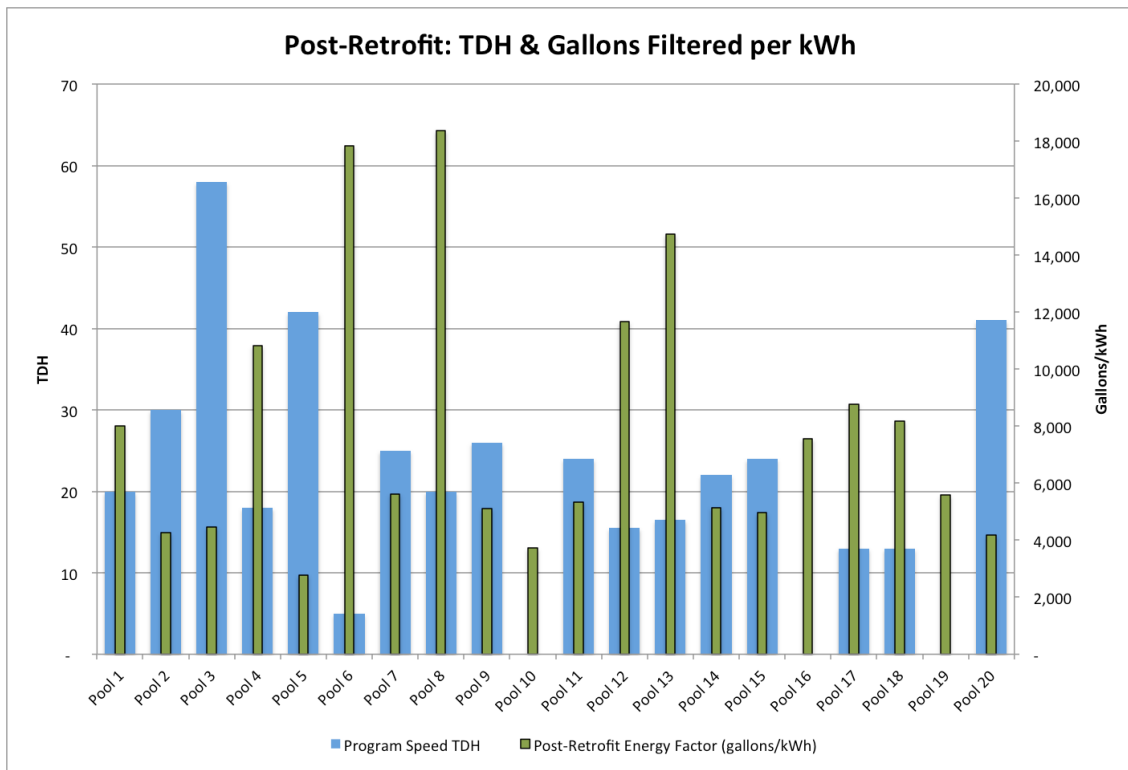
*Note: Pool 3 TDH data was collected prior to non-compliant filter media replacement.*

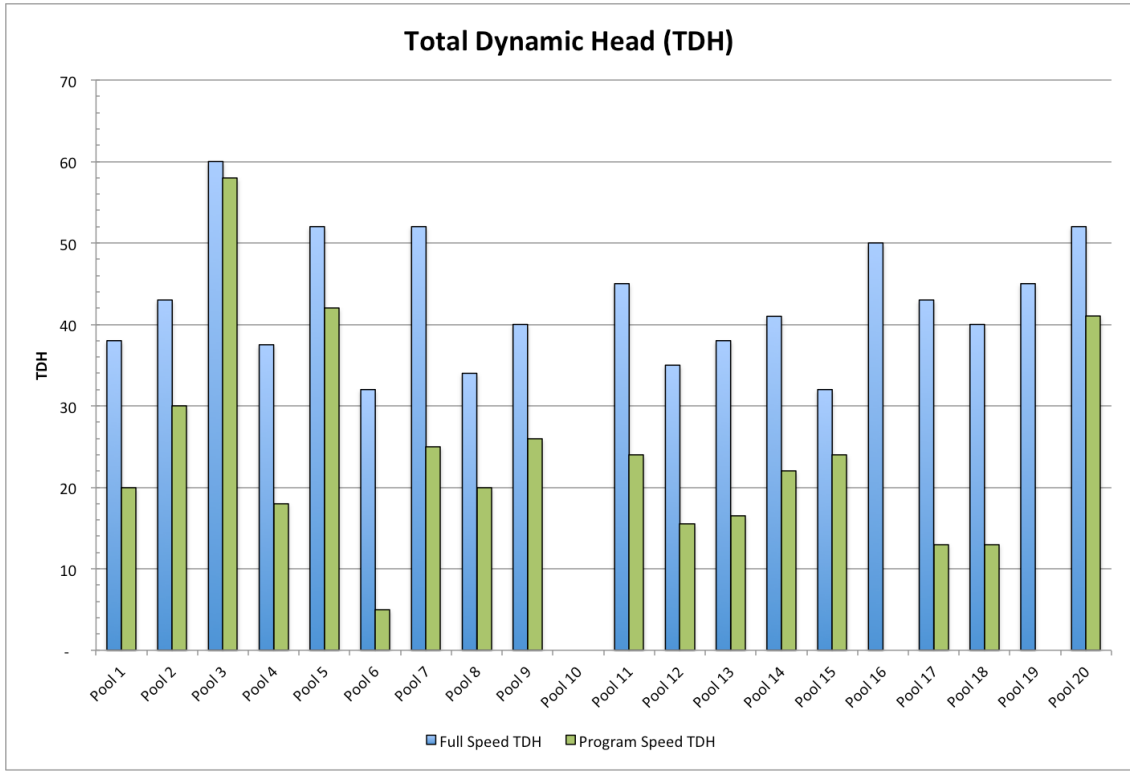
*Note: Pool 3 TDH data was collected prior to non-compliant filter media replacement.*

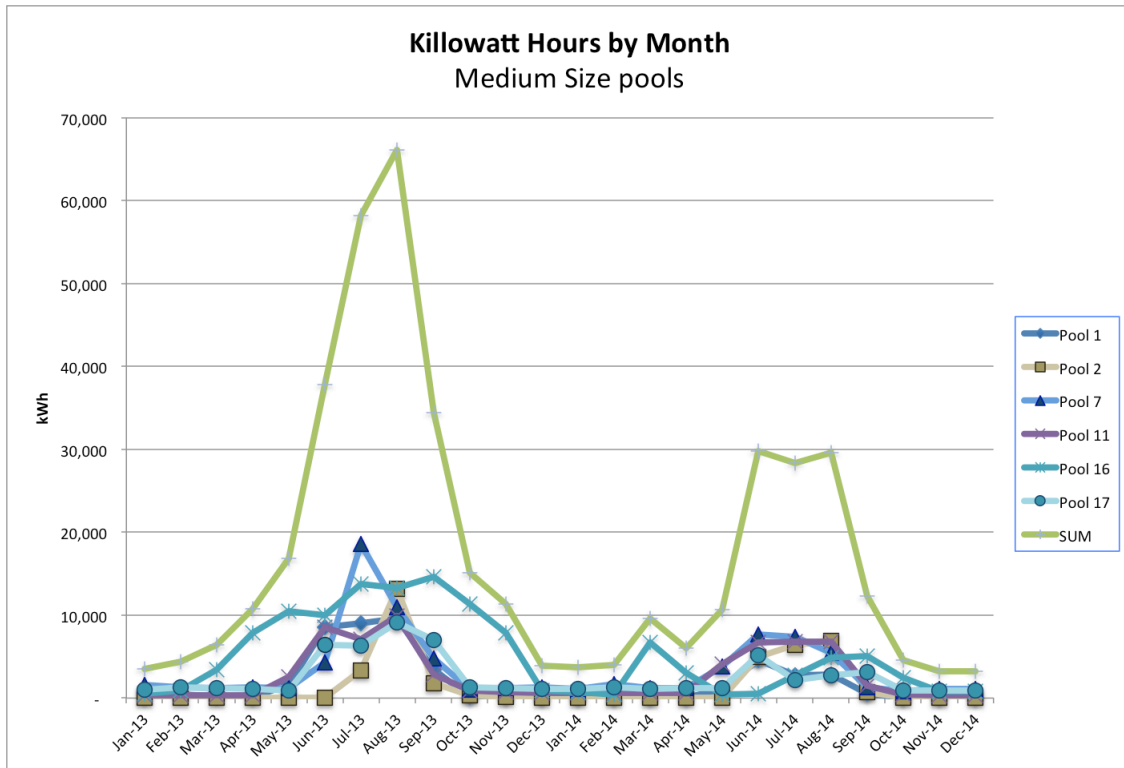
Note: Pre-retrofit and post-retrofit kWh from utility meters. Retrofit process completed May 2014
